| To: | HDR Inc. | Date: | June 8, 2023 |

**CVRD SEWER CONVEYANCE SYSTEM PROJECT  
GEOTECHNICAL CONSIDERATIONS FOR SEWER ALIGNMENT OPTIONS**

CVRD SEWER SYSTEM CONVEYANCE PROJECT

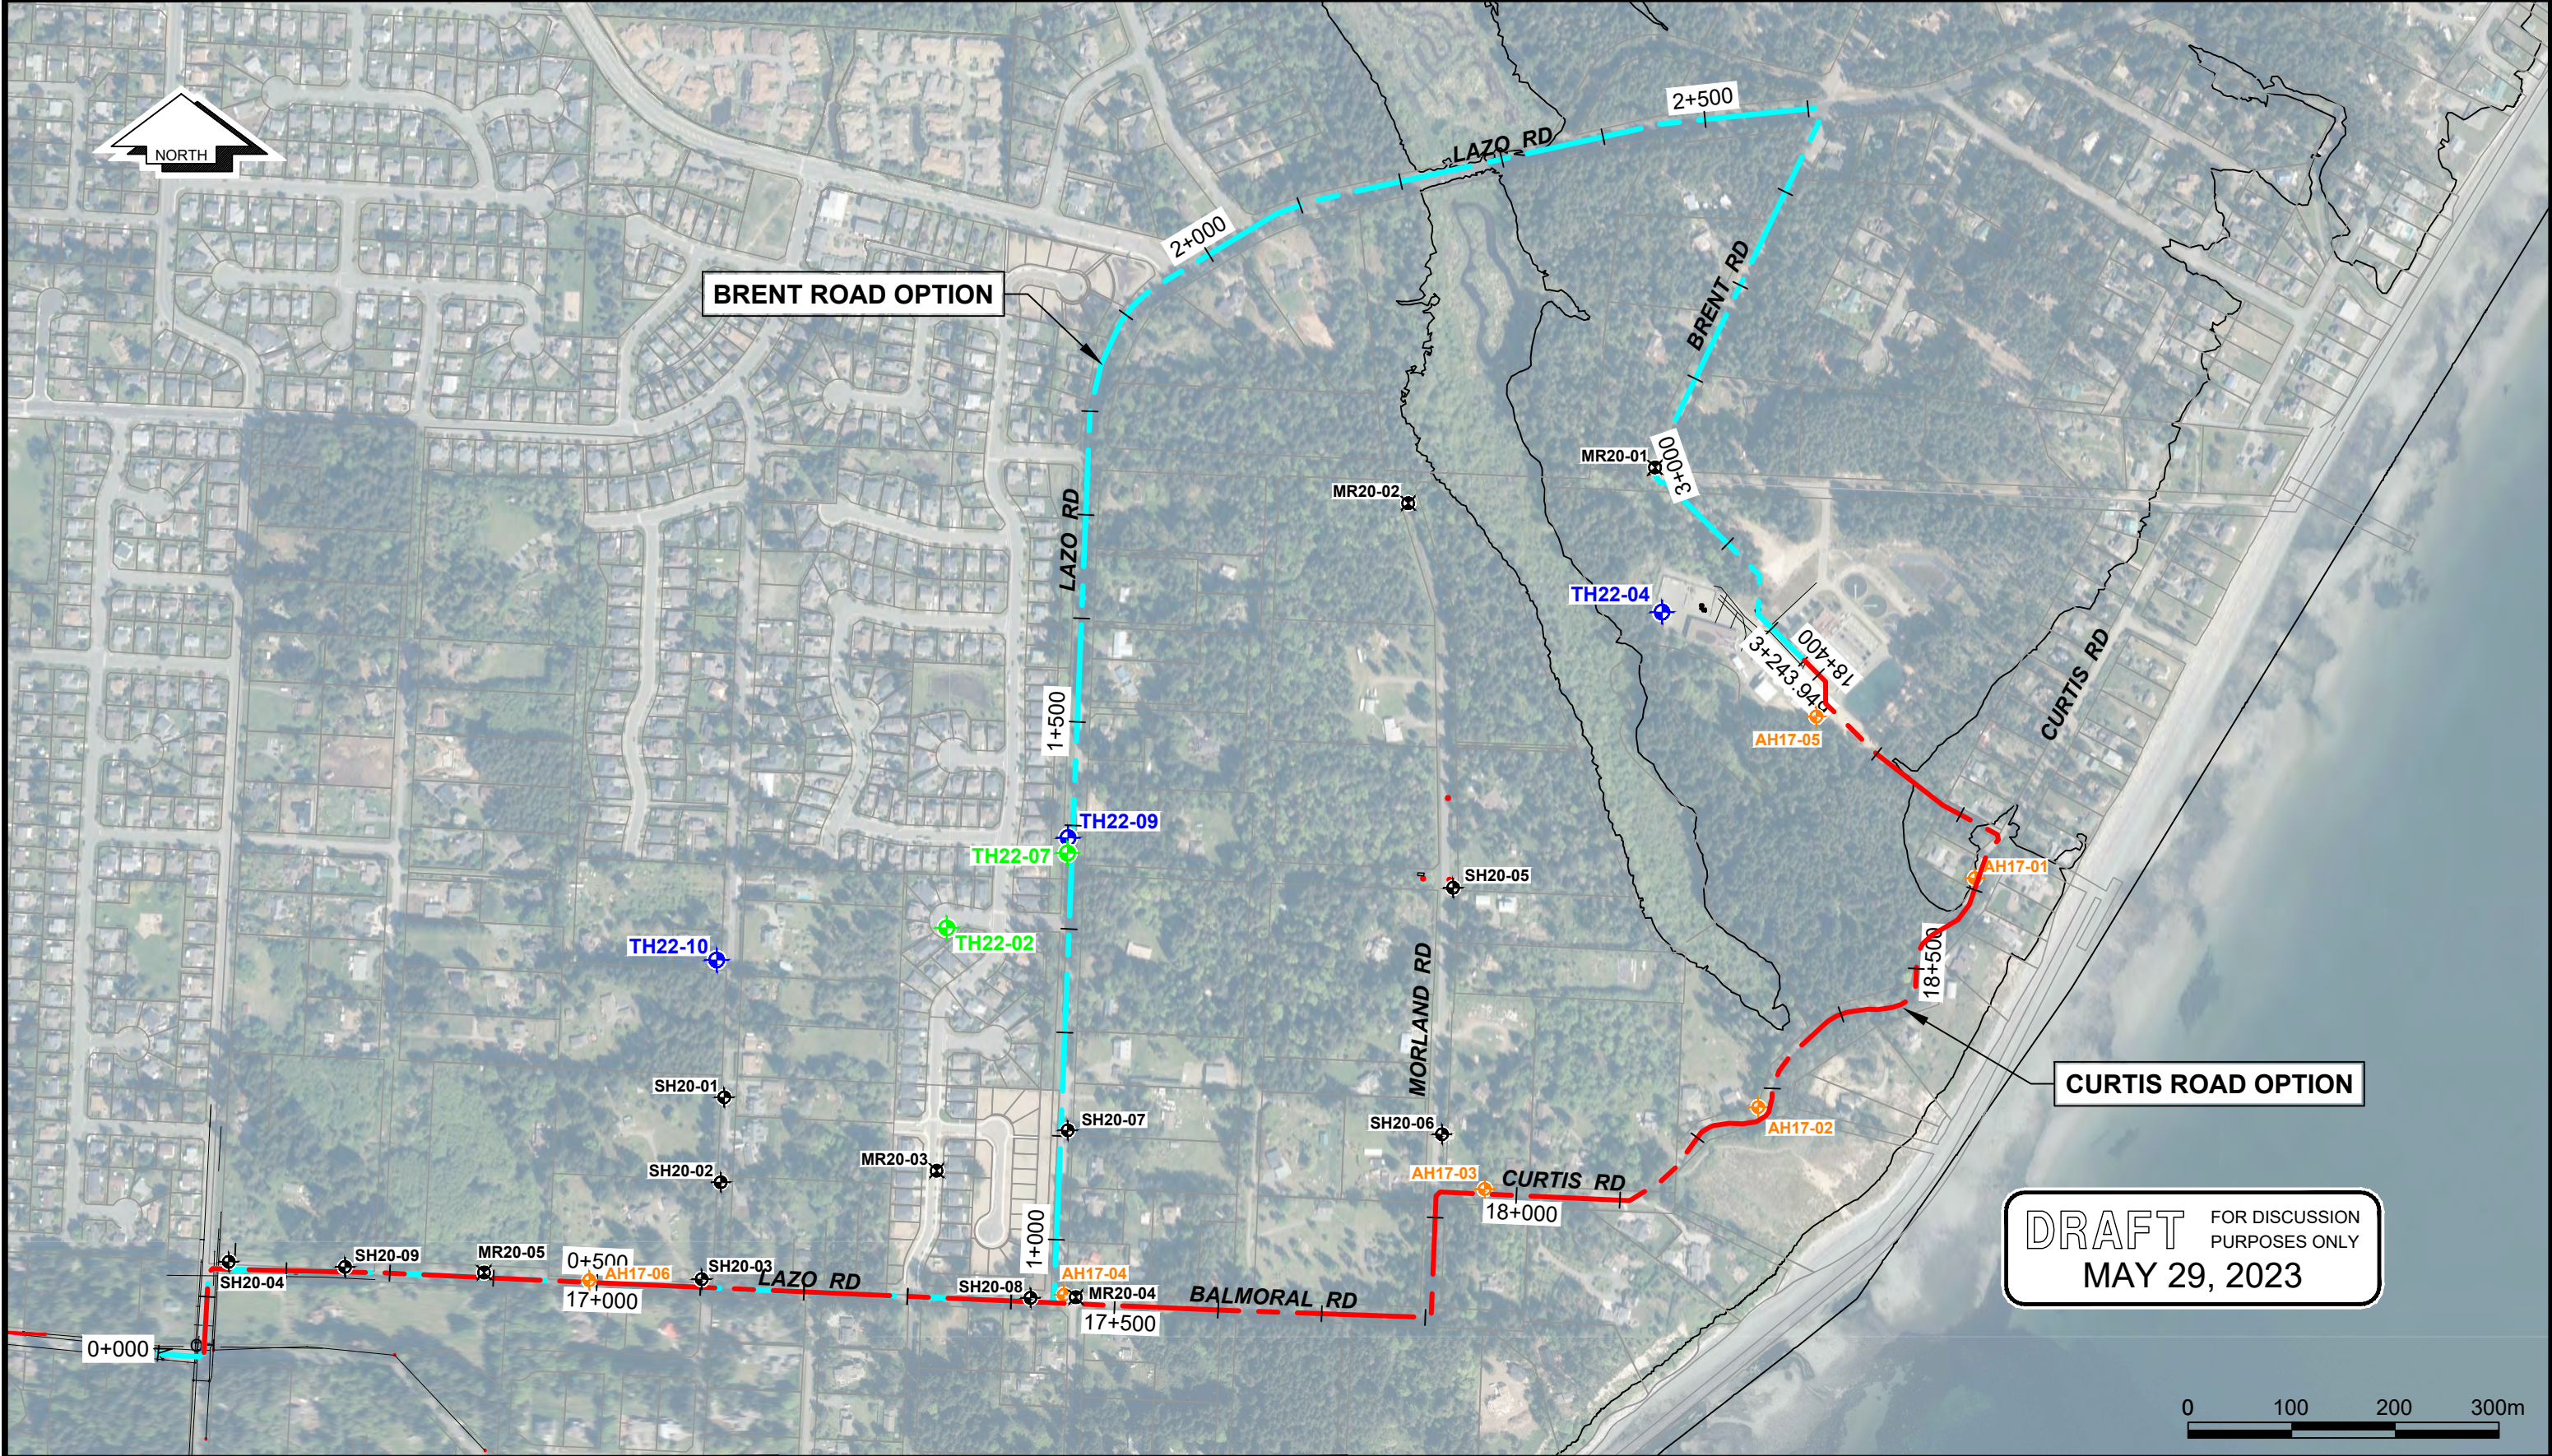
| MPD | DRB | SMB | MAY 29, 2023 | 1:6,000 | 31226 | FIGURE 301 | - |

The Curtis Road alignment is about 1.4 km long and extends east along Balmoral Road from the intersection of Lazo Road and Balmoral Road, north along Morland Road, then west along Curtis Road to the Treatment Plant. The Brent Road option is about 2.3 km long and extends north along Lazo Road from the intersection of Lazo Road and Balmoral Road and then south along Brent Road to the Treatment plant. The two proposed alignments are shown on the attached Figure 301.

**CURTIS ROAD OPTION vs BRENT ROAD OPTION**

- Curtis Road Alignment – about 1.4 km long (Approx. Sta. 17+500 to 18+900)
- Brent Road Alignment – about 2.3 km long (Approx. Sta. 0+950 to 3+250)
